# Changing effect of place on frontage design in the context of cultural sustainability

Şebnem ERTAŞ<sup>1</sup>, Aslı TAŞ<sup>2</sup>

In this context, in study, there was aimed to examine the effect of spatial changes occurred dependent on time on frontage construct in houses where non-Muslim people who were exposed to population exchange and Muslim people who were settled to the houses which were quit after population exchange in the settlement of Sille that is connected to the city of Konya.

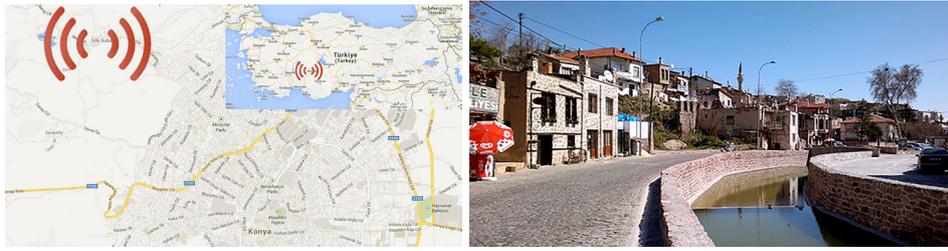
Figure 1. The location and general view of Sille (The Map, 2016), (The Suffagah, 2016).

Sille that is 8 km far away from the center and located in the north-west of Konya city is a settlement whose past goes back a long way and which played host for many empires as Greek, Byzantine, Seljuks and Ottomans (Erdem et al., 2010)(Figure 1).

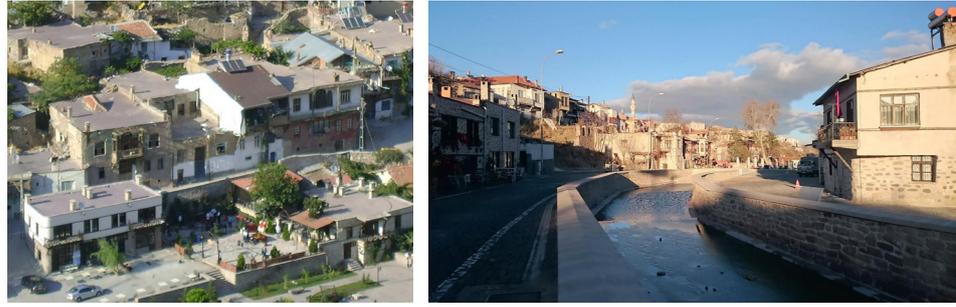
**Figure 3.** Cubic exterior remodeling view of Sille (*The Meramderem*, 2016), (Ertaş, 2016).

which has the cubic architectural style that is unique to the region on the slopes and with the flat roof, sloping and integrating with sloping topography (Erdem et al., 2010)(Figure 3).

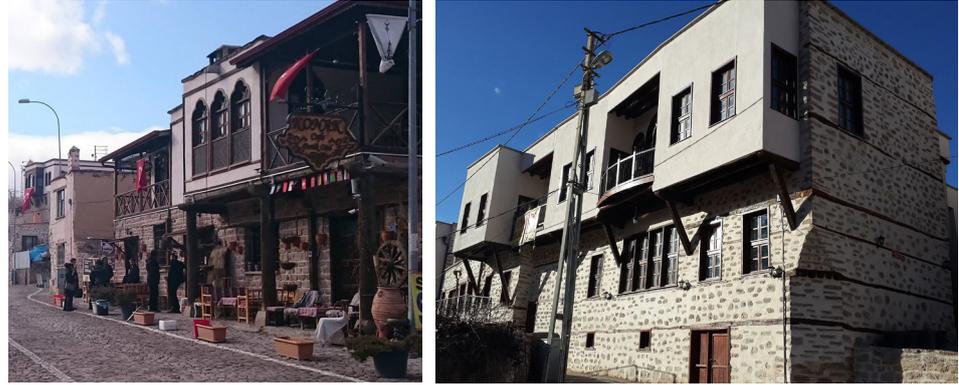
**Figure 4.** The two-storey Sille houses (Ertaş, 2016).

position of the structure in the sloping terrain and the relation of housing with the street. The entering to the Sille housing that is generally two-storey is sometimes from the single door and sometimes from two doors and this situation is determined by the topography of the land (Aklanoğlu, 2009) (Figure 4).

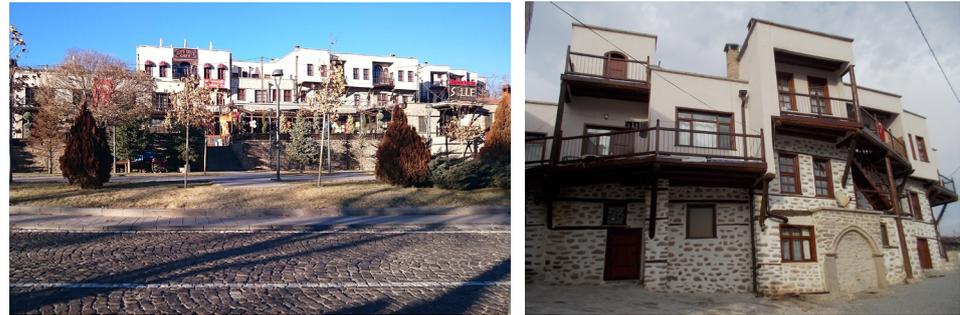
**Figure 5.** General view of the Sille houses (Ertaş, 2016).

In terms of frontage character, Sille houses generally reflect the frontage features of traditional Turkish Anatolian House (Erdem et al., 2010). Hall space is an important factor in the plan schemes of houses that affect the frontage. Hall generally takes place in the middle of the plan and the frontage could be symmetrical accordingly (Şahin, 2010). The overhanging parts generally have been as the outer extension of hall or balcony in houses formed according to the slope of the land (Figure 5).

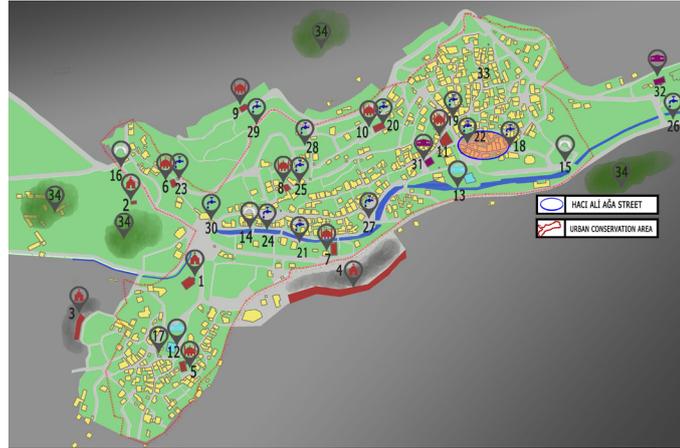
Figure 6. The general view of Hacı Ali Aga Street.

Hacı Ali Aga Street takes place at the entrance of Sille on the main axis in terms of its location. Street is located in the center of historical settlement and there are a lot of cultural assets around it. The Street has the value of a rich cultural heritage with the structures that have either house features or commercial features (Figure 6). Hacı Ali Aga Street that has the cultural, historical and touristic source values is in the area that was taken into consideration as the protected area in 2001 and it consists of mostly 2nd Degree proprietary structures that maintain their original condition. The latest frontal improvements have been made for most of the structures by Seljuk Municipality in 2015.

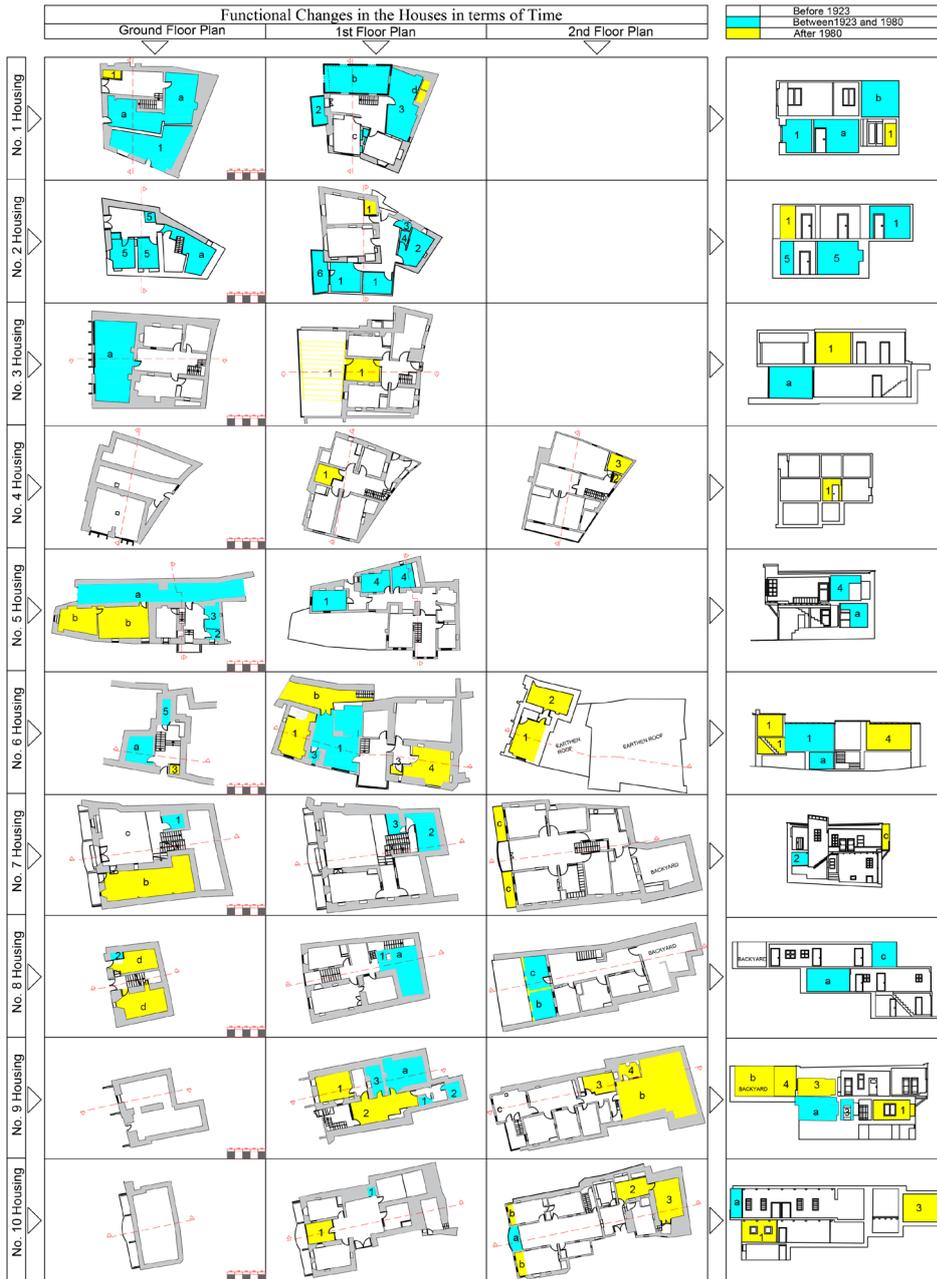
As a result of functional changes, The graph of time-dependent functional changes in 10 houses on the following schematic is tabulated together in plan and section plan (Figure 13).

Figure 13. The graph of time-dependent functional changes in houses.

Functional change tables have been factionalized to reveal the 3 (three) periods determined depending on the culture change occurred in the residential area. The time concept in functional changes was explained by coloring method. The changing functions of spaces in these periods have not been encoloured before 1923 and the period between the years of 1923-1980 was shown with blue color and the period after 1980 was shown as the yellow color. On the other hand, the fronts were renewed with the restoration project in 2015 and the spaces changed correspondingly were processed after 1980.

ed spaces and the spaces which were changed. The spaces added in the first group were determined, but in the second group, the spaces changed because of removal or degradation was examined. In order to ease the comprehensibility of the changes in tables, the spaces added through the plan section were shown with numbers and changing spaces were shown with letters.

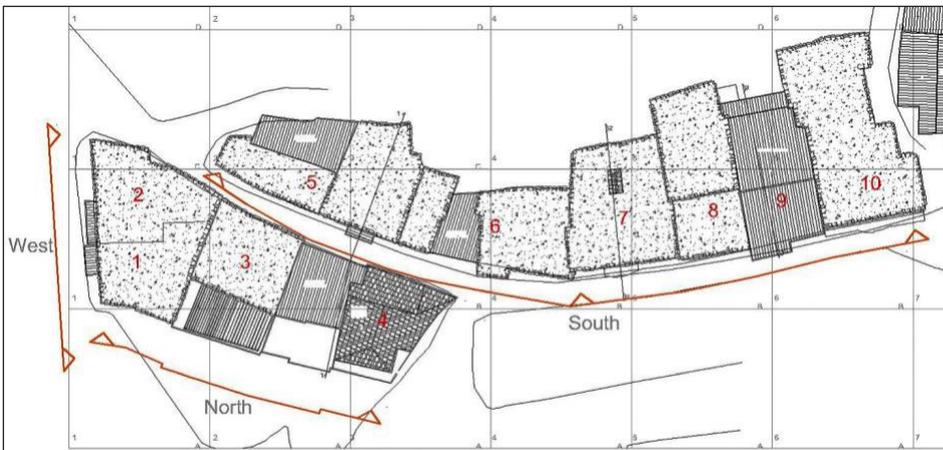
General view of Hacı Ali Aga Street in terms of South and West frontages and the facades of northward buildings (Figure 14).

Figure 14. Hac1 Ali Aga Street, the frontage locations of genuine ten (10) houses.

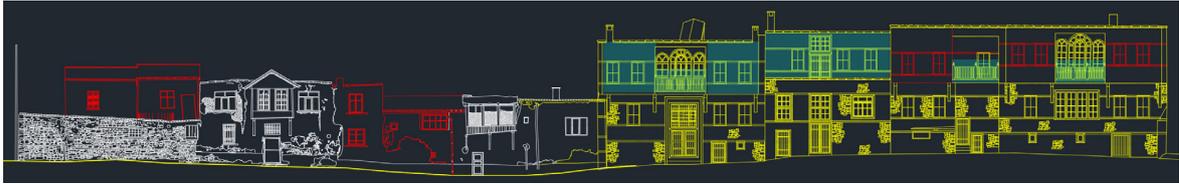
The houses numbered 1, 2, 3, 7, 8, 9, 10 were changed again during street rehabilitation and the project was not applied on houses numbered 4, 5, 6. The old elements were removed depending on the changes until 2015 on windows, doors that are at frontages and the renewal was carried out. In some part of them, the changes were done in interior space and on the character of frontages by making the adding. Inside the period from pre-1923 period until the period after 1980; red color meant adding, the blue color meant removals and yellow color meant the renewals according to rehabilitation projects and the changes on frontages are illustrated below (Figures 15, 16).

Figure 15. The south frontage.

Figure 16. The northward frontage and west frontage.
