The Origins of Reinforced Concrete Interventions to Historic Structures in Turkey

Zeynep Inan Ocak & Chiara Calderini

^aDepartment of Architecture, Marmara University, Istanbul, Turkey; ^bDepartment of Civil, Chemical and Environmental Engineering, University of Genova, Genova, Italy

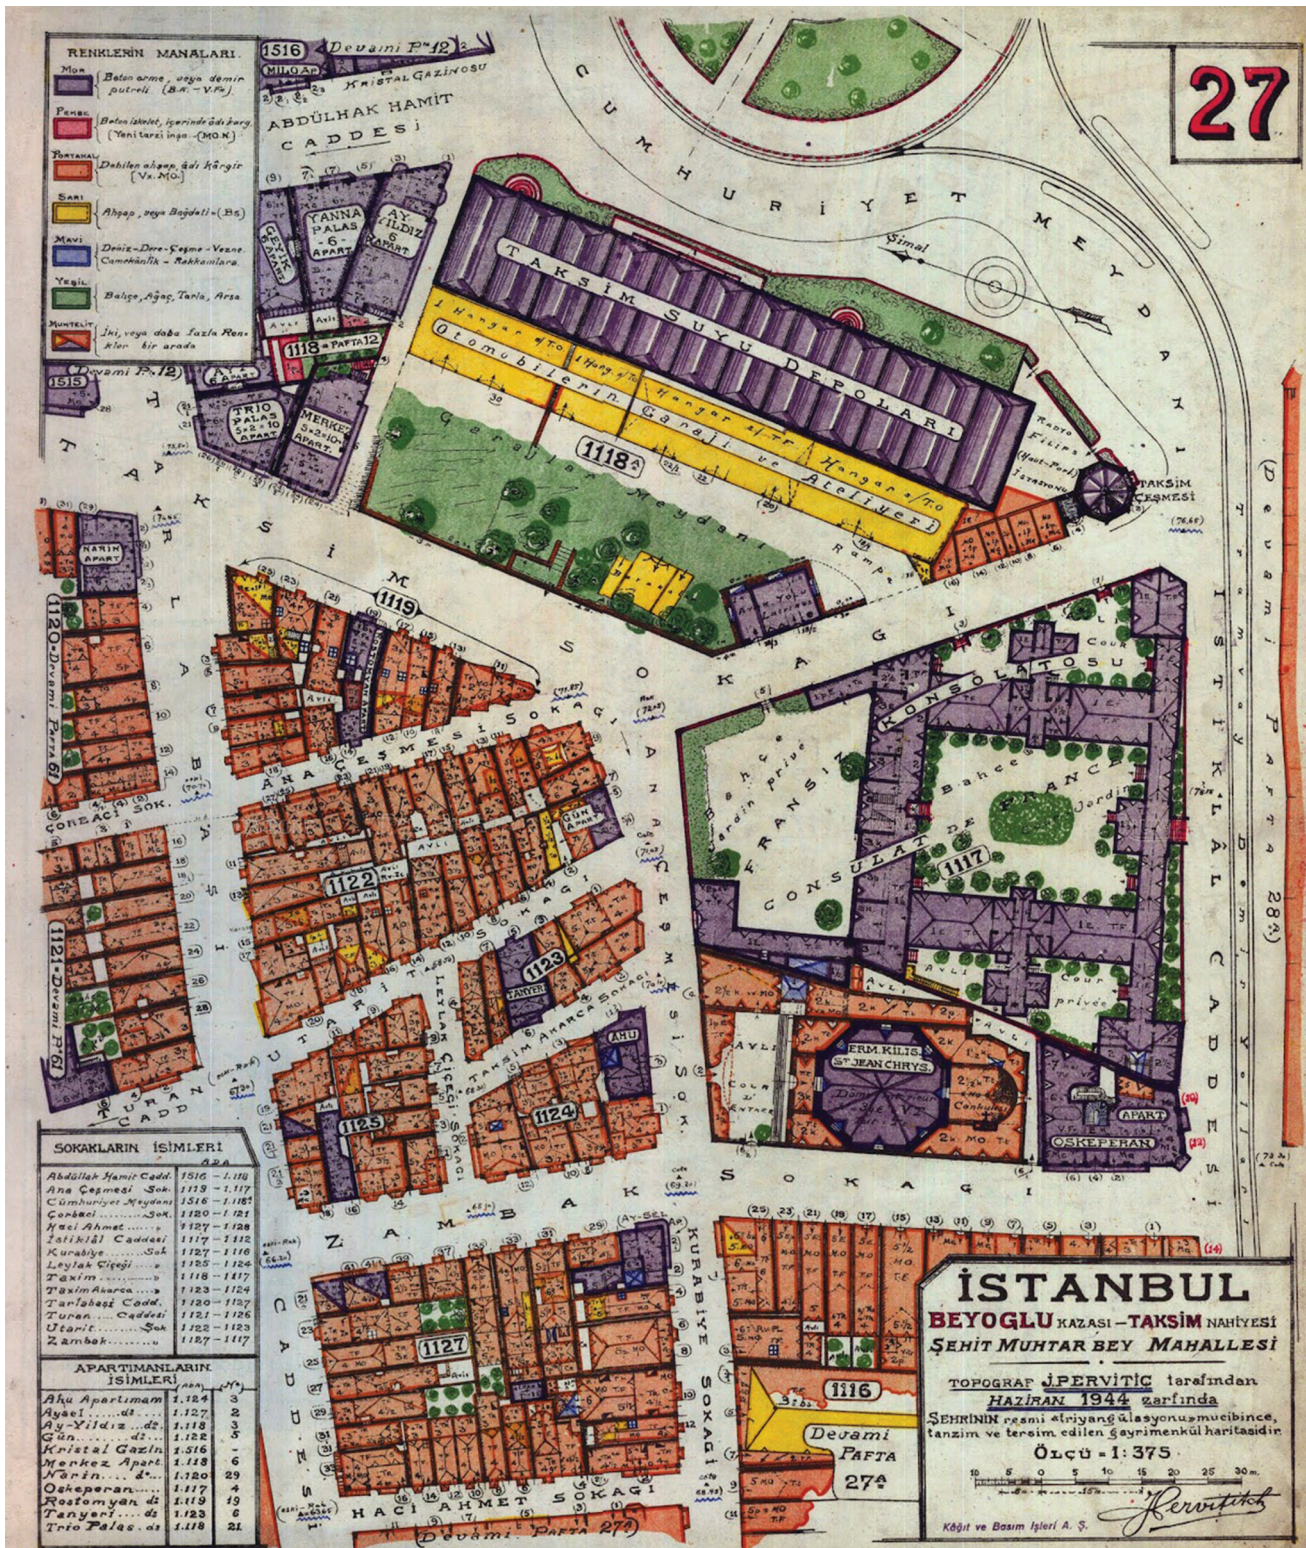
Figure 3. Pervititch insurance map, with legend designating construction techniques. Violet and pink colours indicate the use of RC (Ersoy and Anadol 2000).

Perspectives on protective measures against fires differed notably compared to earthquakes as the issue of protecting traditional timber houses in Istanbul from fires was always on the agenda. Timber was an abundant and versatile construction material in this region, used not just for residential buildings but also in the construction of small-scale mosques. Interestingly, it has been suggested that the introduction of extensive wooden structures in Istanbul was initially a preventive action in response to the major earthquake of 1509 (Şahin Güçhan 2007). Regardless of the reason for its use, wood soon became a threat in the city, which struggled with fires. Urban fires had a profound impact on the built environment, prompting both changes in construction techniques and materials and the initiation of insurance studies and subsequent mapping efforts, such as the notable Pervititch and Goad maps (Ersoy and Anadol 2000). These maps clearly demonstrate the spread of RC in fire-affected areas (Figure 3).

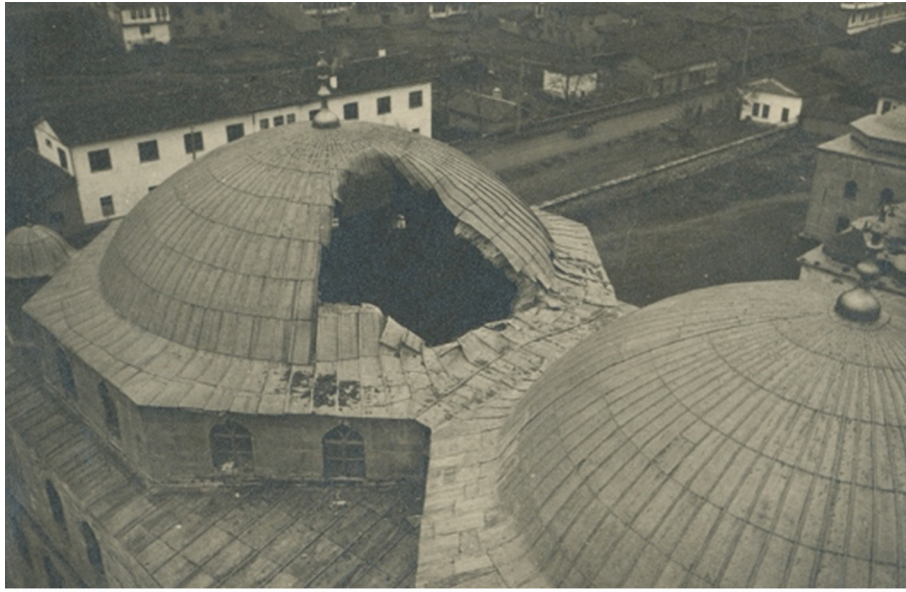
Figure 7. Document related to the repair of Sultan Bayazit Mosque in Amasya, 1949, following an earthquake, with concrete-related purchases underlined in yellow (source: Ali Saim Ülgen Archive, Salt Research 1949).

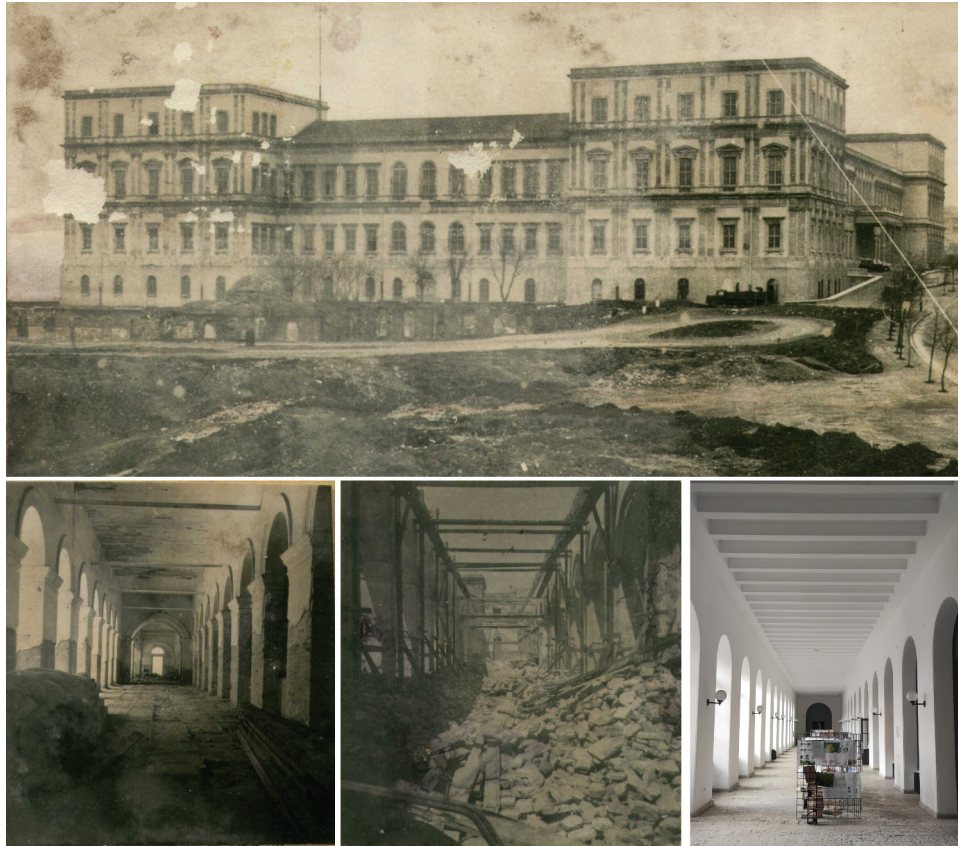
Figure 10. Substitution of wooden elements with reinforced concrete at Taşkışla, an Ottoman military building converted to the faculty of architecture of Istanbul Technical University in 1944 (source: encümen archive file No. 1107, Istanbul regional board of conservation of cultural heritage [Istanbul technical university faculty of architecture Taşkışla building]).

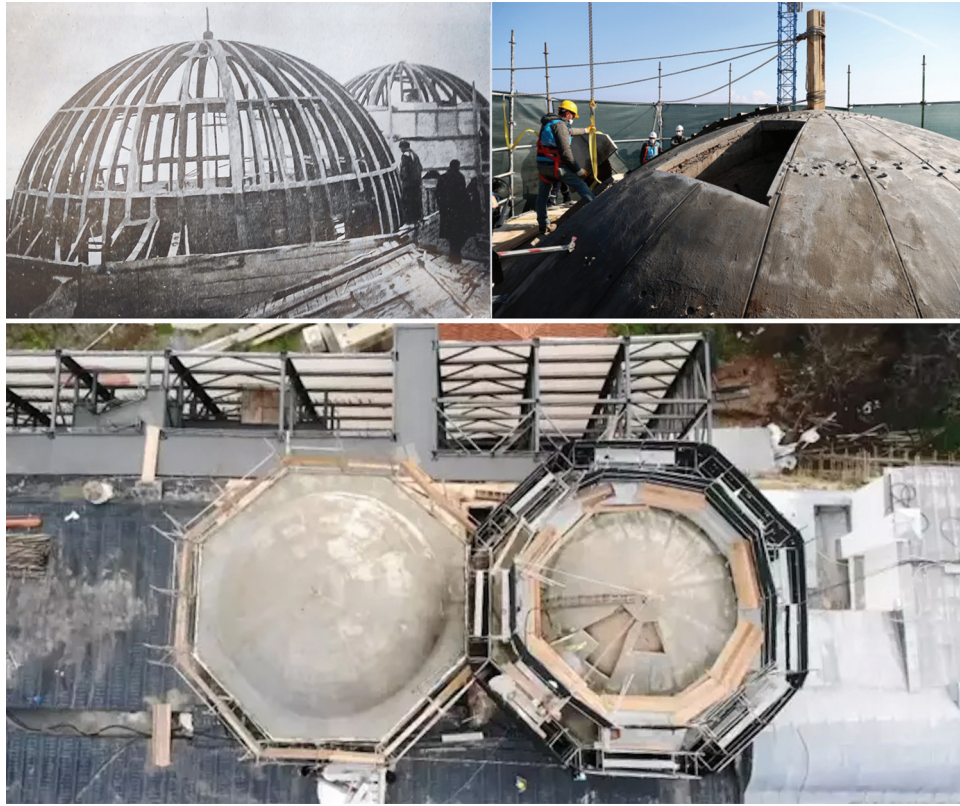
Figure 14. Topkapı palace, Fatih Mansion: conversion of original timber dome to RC dome in 1942 and its dismantling in 2021 (sources: Öz 1991, 51 [top left]; Ergör and Benlioğlu 2021 [top right and bottom]).

restoration works that started in 2019, the RC domes of the mansion were removed due to the heavy load on the structure and the cracks and sliding they had caused, and then it was aimed to restore the structure to its original Ottoman state.

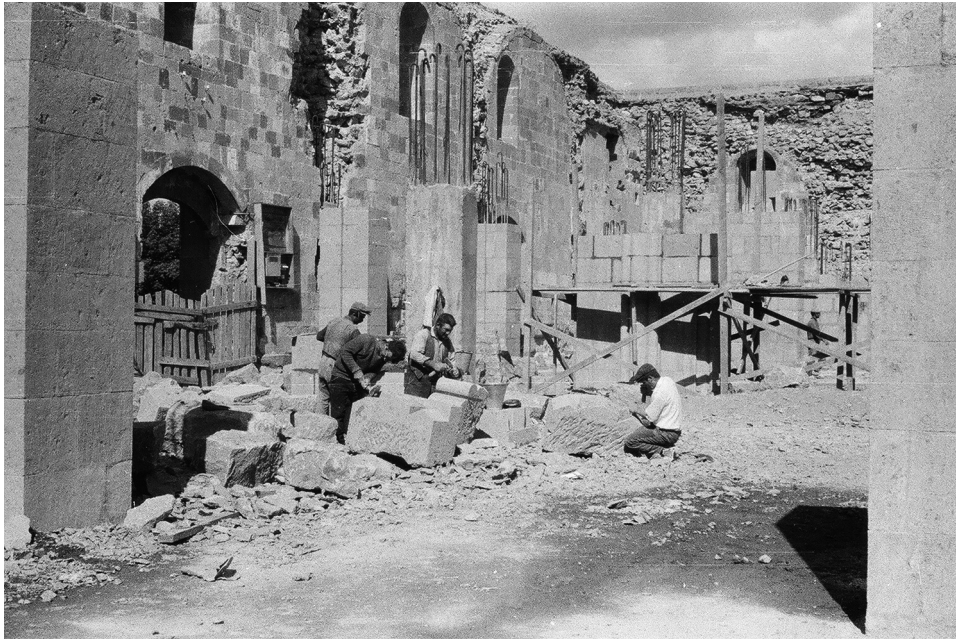
Figure 15. Restoration of the grand mosque of Erzurum in the 1960s with stone masonry and RC techniques side by side (source: VGM archive, <https://www.vgm.gov.tr/kurumsal/vakif-kayitlar-arsivi/vakif-kayitlar-arsivi>).

masonry, referred to as a mixed system. In several structures, such as the Vakıf Hans of Istanbul, the edifice would exhibit a masonry appearance but RC parts would be structurally integrated into the masonry. The application of this type of construction could be described as a first phase of transition, during which expertise in the use of RC was acquired while traditional techniques were still being applied. In this context, interventions to monuments involving RC persisted into the following years as an extension of this transition while the predominant use of RC in the construction of new buildings was being witnessed (Figure 15).
